Troubleshooting Guide

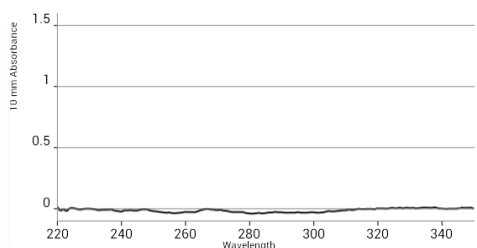
Note: Water or buffer sample measurements will not result in perfectly flat lines.

The image to the right is typical of what is expected of a water sample.
